## **FAILURE OF VAPOR OVERHEADS DISCHARGE LINE FOR A RADIOACTIVE WASTE EVAPORATOR**

C. F. Jenkins  
Westinghouse Savannah River Company

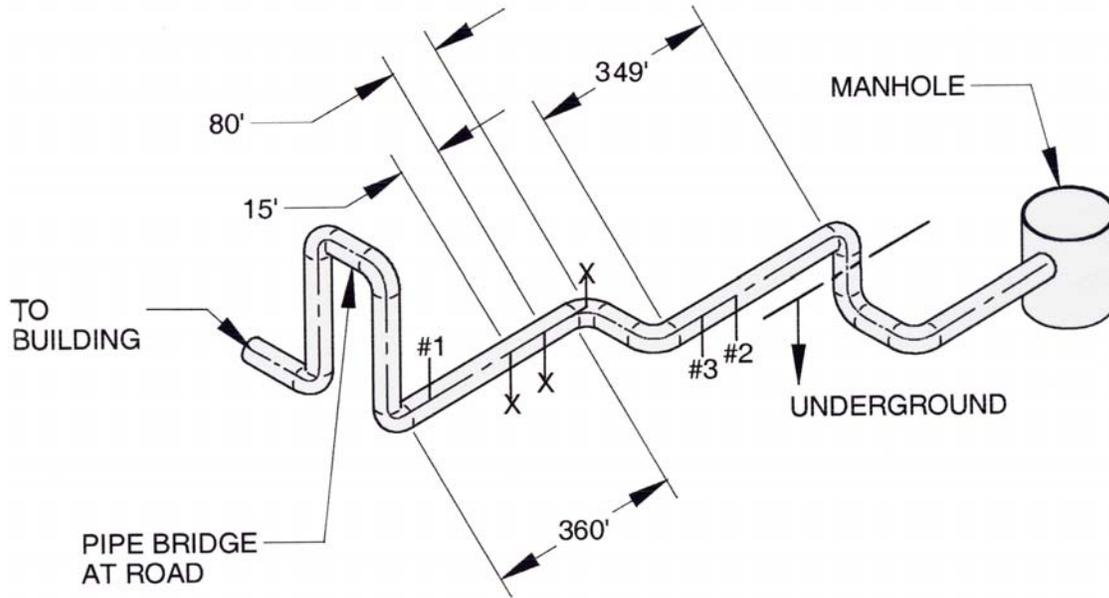
A leak to the annular space of the jacket pipe was discovered during test runs in August 99. The leak was located downstream of the road crossing (high point). Further investigation revealed five additional openings or holes in the pipe, Figure 1. All of the openings were bursts and exhibited a “fish mouth” or “pucker” appearance. The steel was permanently stretched into that configuration, Figure 2. The failures were examined to determine the nature of the breaks.

FIGURE 1. Sketch illustrating the non-insulated, above-ground portion of the overhead discharge piping from the evaporator. A simple gravity drain connects to a pipe bridge having a 30-foot vertical rise and drop at a road crossing (on the left) and a 12-foot vertical drop further down stream at the manhole end (on the right). A pump at the evaporator facility forces the liquids across the pipe bridge. "X" identifies locations where breaks occurred in the core pipe of the jacketed line.

It was recommended that a vent be installed at the road crossing. The above ground section of inner or core pipe between the roadway bridge downcomer and the vertical step just upstream from the manhole (Figure 1) was replaced with seamless pipe meeting ASTM A106. This pipe also meets the original A53 specification.

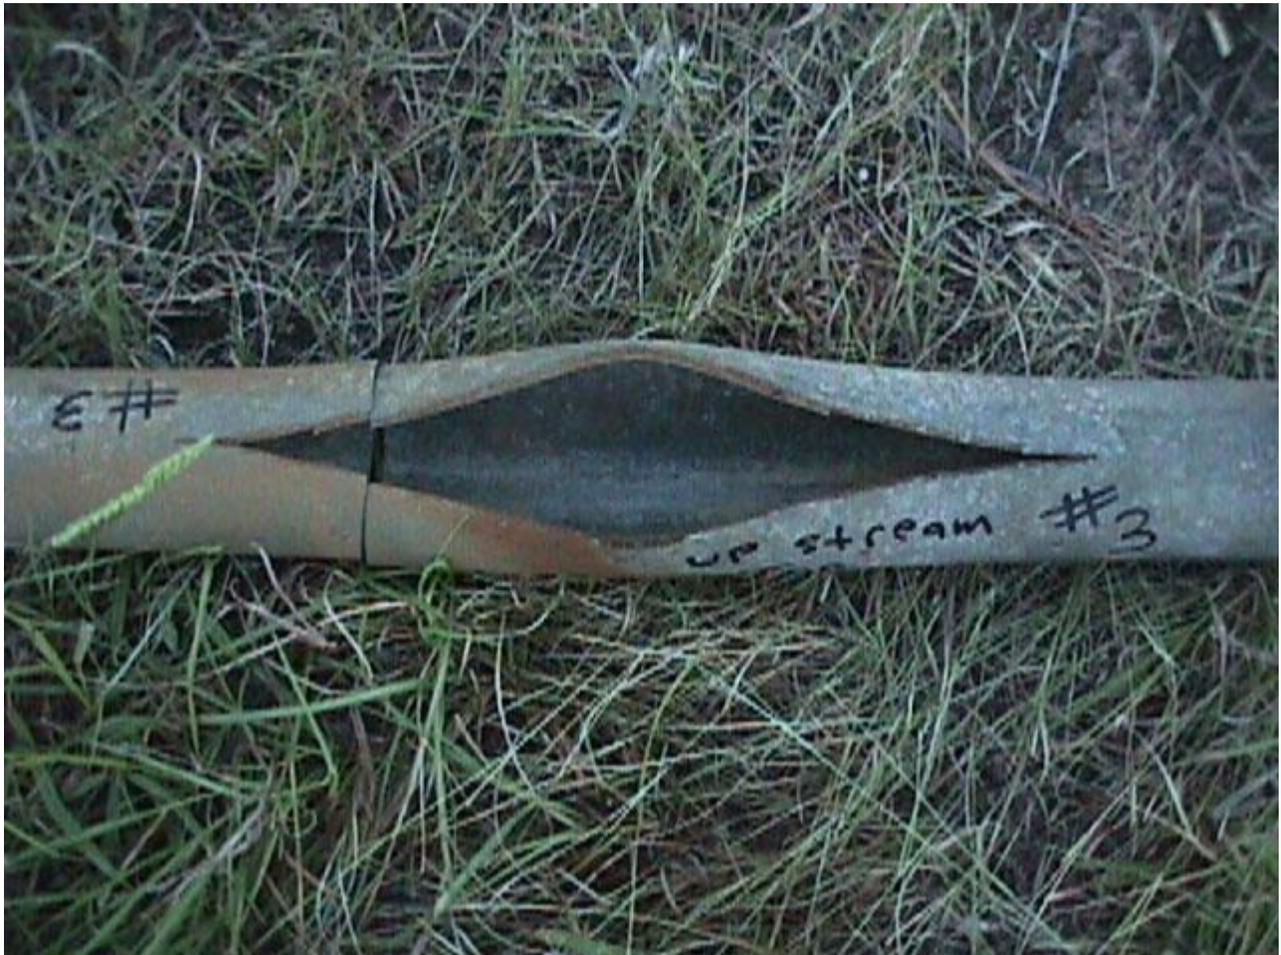
As evident in several bursts similar to that in Figure 2, the breaks are very straight and oriented with the pipe axis. The end points are sharp and project axially in both directions in all but one case. Figure 3 shows break #2 from Figure 1, which involved a butt weld joint. In this case, the axial tear, driven by the burst or expansion, continued in the circumferential direction along the edge of the butt weld. The pipe seams for the two pipe joints did not line up axially across the butt joint. Inspection revealed that no significant corrosion had occurred, and the fractured surfaces exhibited only superficial rusting.

FIGURE 2. Fish mouth break in 2-inch core pipe. This is break #3 in Figure 1.

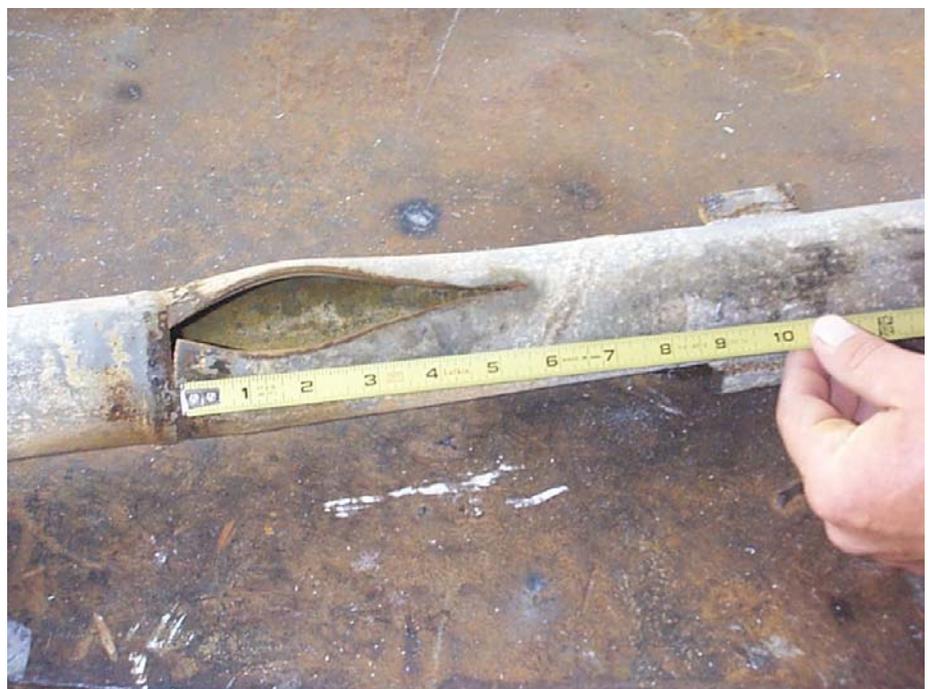
FIGURE 3

Fish mouth break at butt joint. The break on the seam weld continued along the butt weld. This is break #2 in Figure 1.

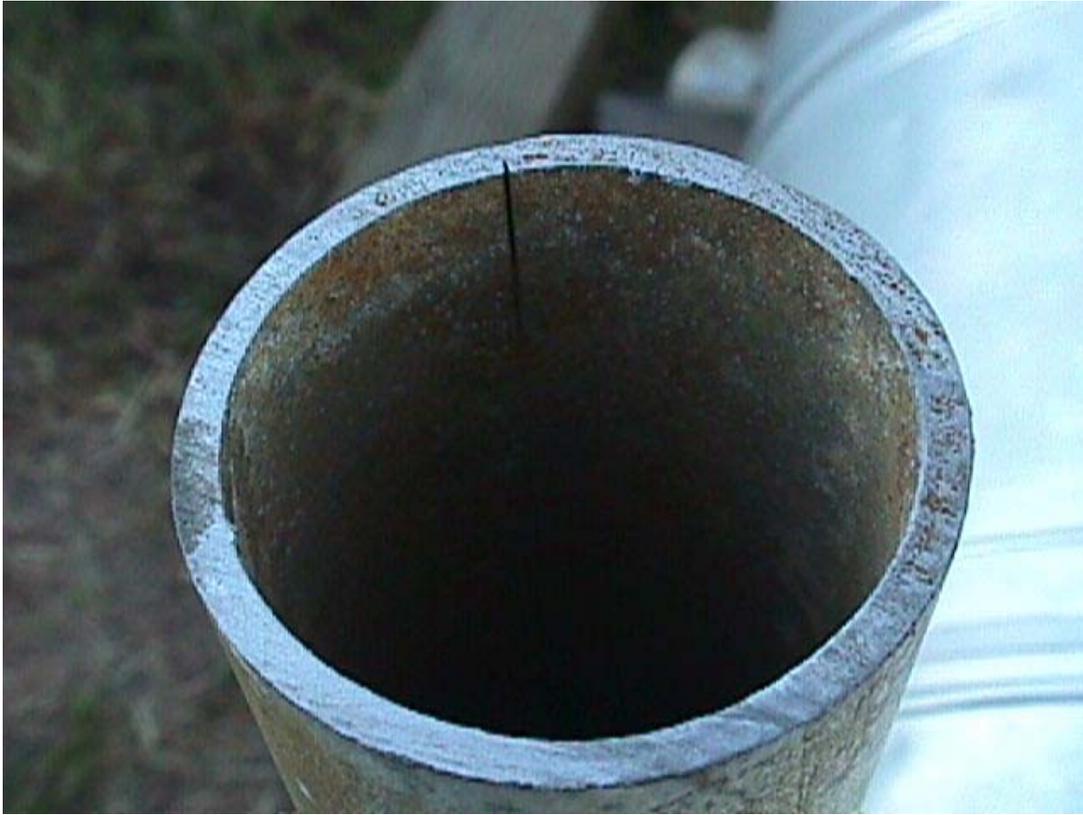
Further visual examination revealed, in each case, that the split or tear was aligned with a longitudinal or axially oriented indication on the internal surface of the pipe. This appeared to be a seam weld. Further inspection of one pipe length revealed an axial defect which was at least 2.5 inches long and had a depth of approximately 1/2 wall thickness (Figure 4). This defect follows the indication or weld line on the ID surface.

pipe to be consistent with ASTM A53, Grade A, Type E steel. Note that the flaw dimensions in Figure 5 are within ASTM acceptance limits, but the deep flaw in Figure 4 would be cause for rejection at the mill, had it been seen. Any of the observed lack of fusion imperfections would probably have resulted in failure of an applied cold flattening or “crush” test, in accordance with ASTM A53 criteria. It is presumed that each length of pipe did pass the required hydrostatic test at 2300 psi, though no CMTR’s were found in the project file.

FIGURE 4. Lack of fusion defect on seam weld on interior wall of the core pipe. Appearance is typical. This flaw is  $\sim 2 \frac{1}{2}$  in. long and  $\sim 0.072$  in. deep (wall is 0.154 in. nominal).

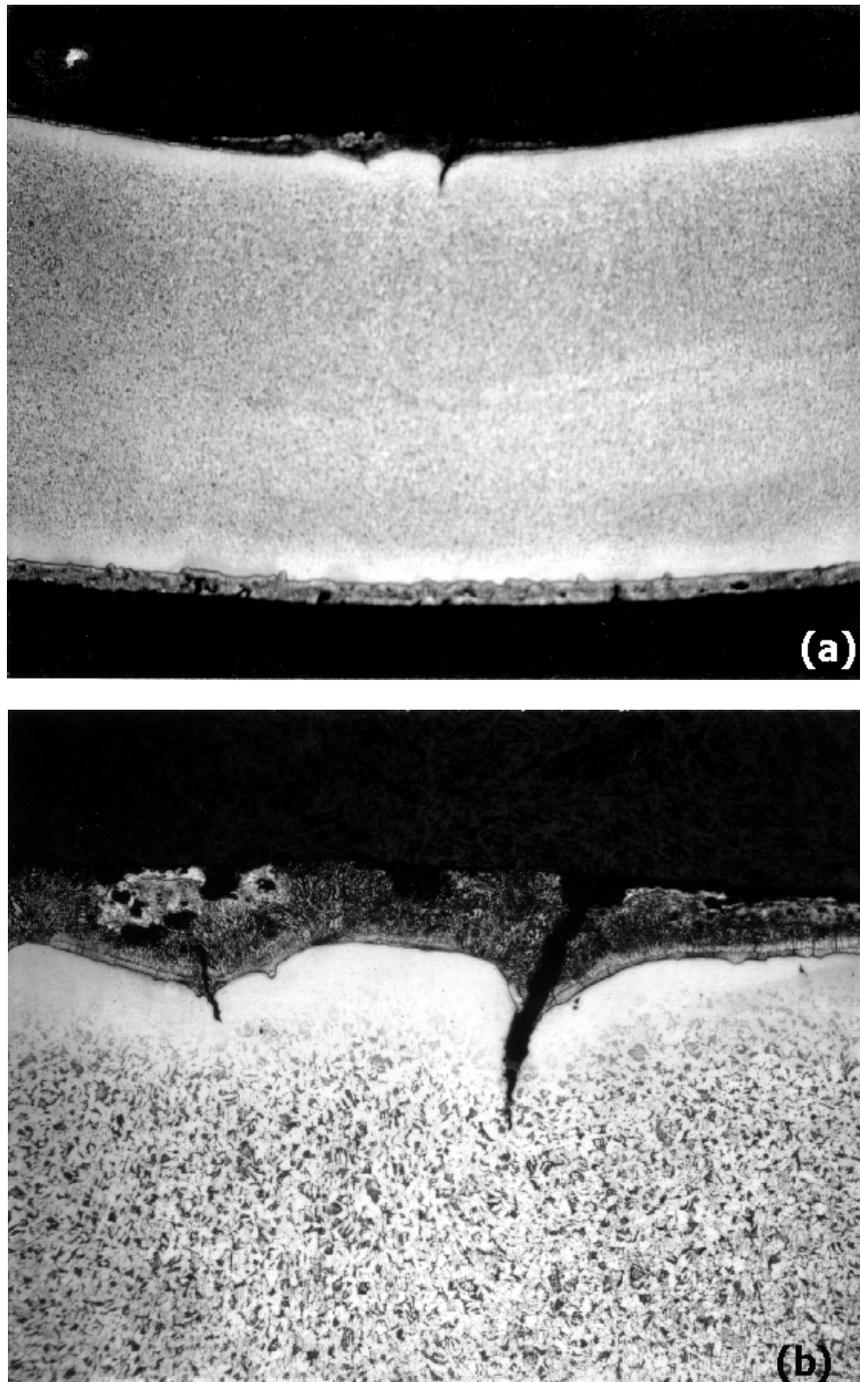
Metallographic study revealed additional smaller linear flaws that had an axial orientation at the weld locations, Figure 5. These are located on the edges of the seam welds and are due to lack of fusion at the weld. The microstructure of the steel is typical for normalized low carbon steel, the heat treatment having occurred at the mill subsequent to welding and perhaps to the sizing operation for the schedule 40 dimensions. The seam appearance is consistent with an electric resistance weld. Grains have a generally radial orientation in the vicinity of the weld, and the weld defects are aligned with the crystal boundaries. Laboratory analysis indicates 0.21% carbon content for the pipe. These data confirm the

Study of Figure 5 shows the ID weld flaw on the right cracked through the galvanized zinc coating, whereas the flaw on the left did not break the external surface of the coating at this specific location. However, it probably penetrates at other locations along the weld line. In most cases, the hot dipped galvanized zinc coating appears to have good bonding to the pipe. Figure 5 shows some cracking and porosity in the iron/zinc layers, but also evidence of good bonding to the steel. Figure 6 shows a case where the zinc has been chipped or has spalled in a small area on the exterior surface of the pipe. Peeling or cracking in the zinc coating extends axially from the chipped area in both directions. The damage is probably due to a combination of poor local bonding and rough handling.

FIGURE 5. Cross section of galvanized A53 carbon steel pipe. Sharp defects occur in the toe of the seam weld on the inside wall of the pipe. Magnification: 16X, 64X .

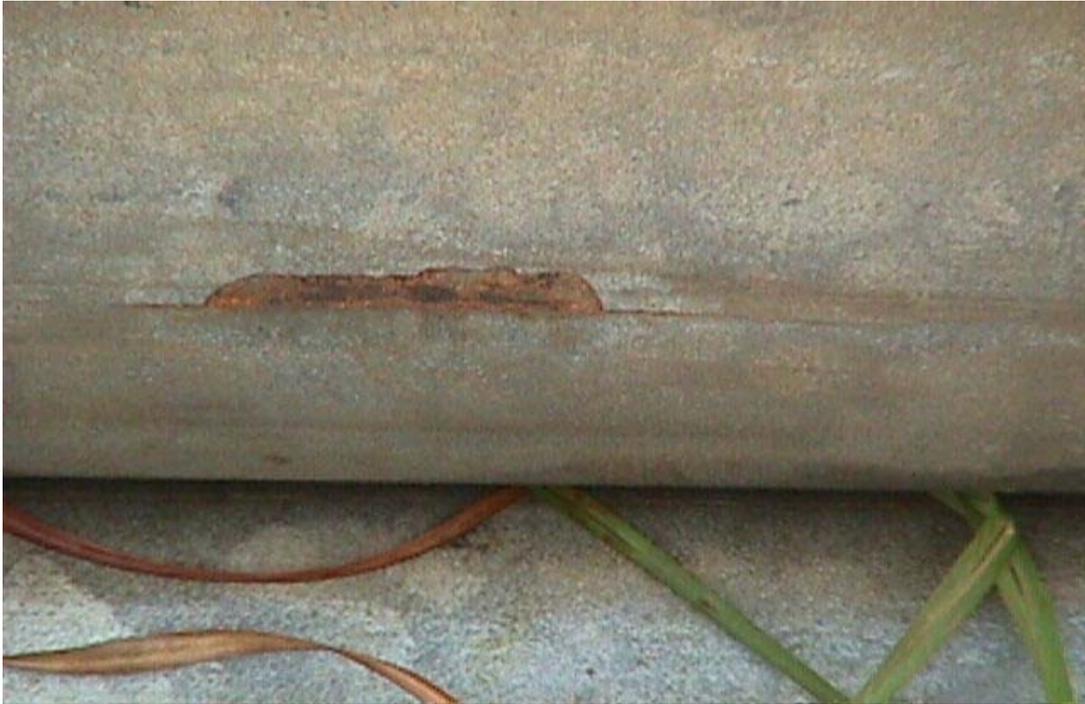
FIGURE 6. Galvanized pipe from overheads discharge line. A long axial crack and flaking are evident in the zinc coating. Bonding of the zinc is questionable at this location.
